September 28, 2021

**Subject: Providence Road Commons
Construction Completeness Review**

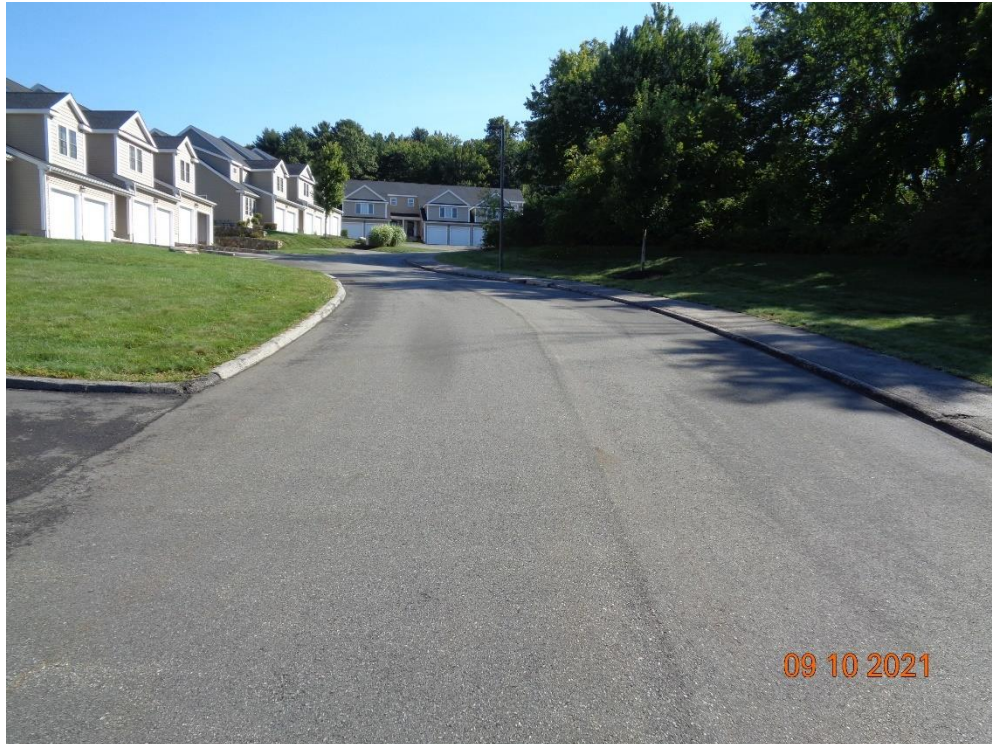
1. Based upon visual observations during our site visits and our review of the as-built plans, it appears that the project was constructed substantially in accordance with the approved plans and approved modifications. Please see Photos 1 and 2.

Photo 1: Northern section of Luka Drive.

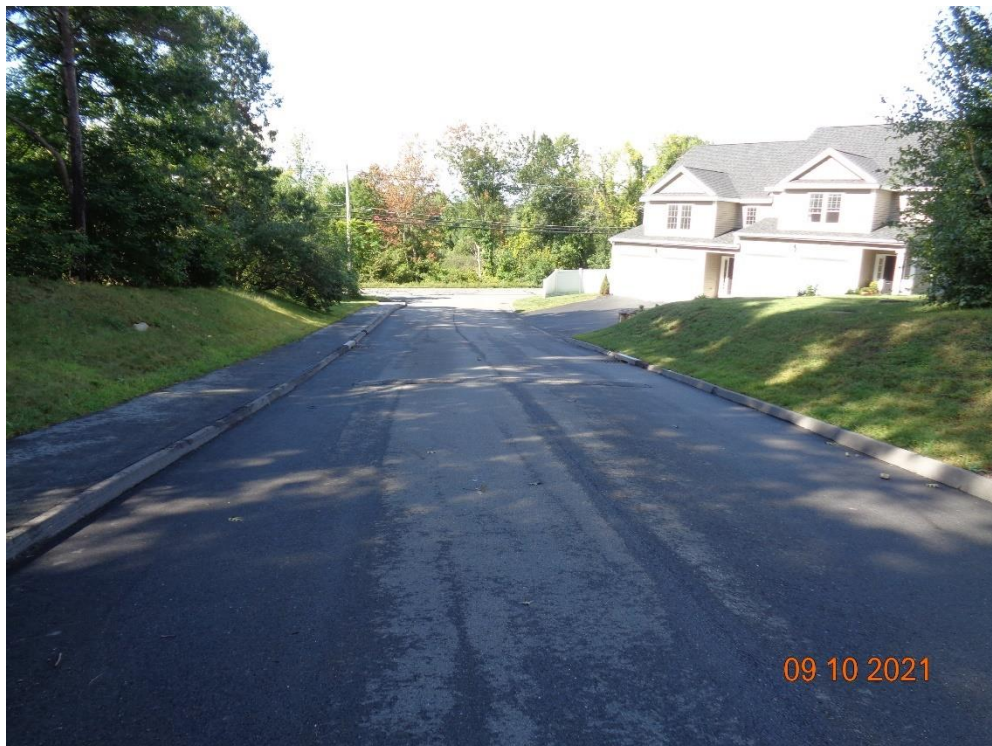
Photo 2: Southern section of Luka Drive.

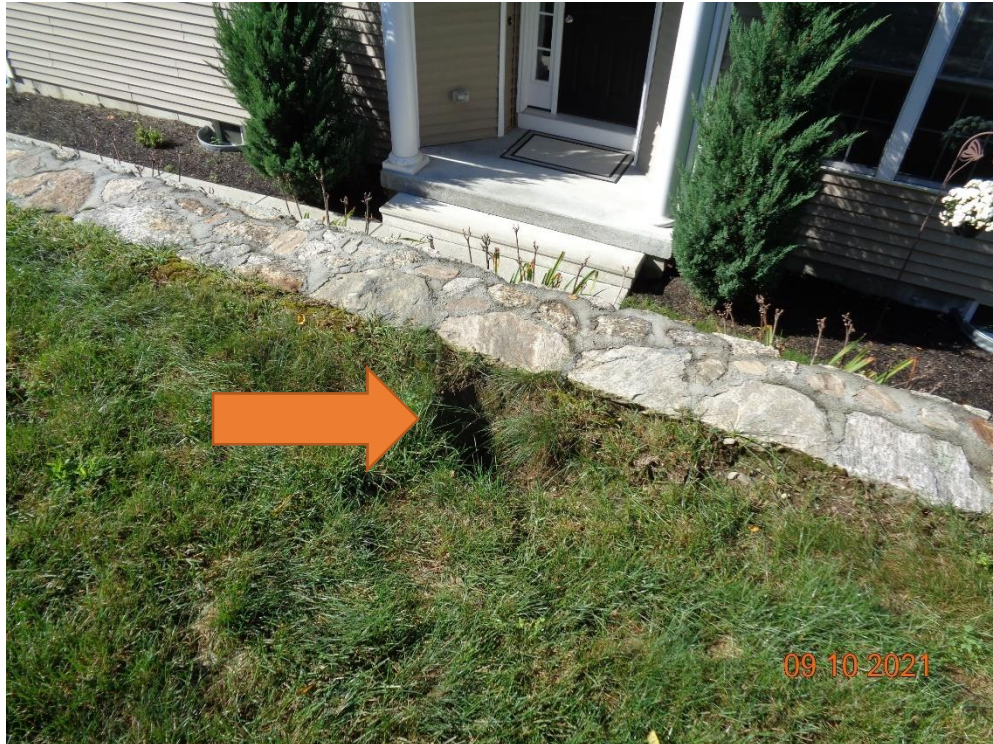
3. A hole approximately three feet by two feet by a foot deep developed at the top of the retaining wall between #17 and #19 Luka Drive. The hole needs to be filled. Please see Photo 3.

Photo 3: Hole that needs to be filled between #17 and #19 Luka Drive.

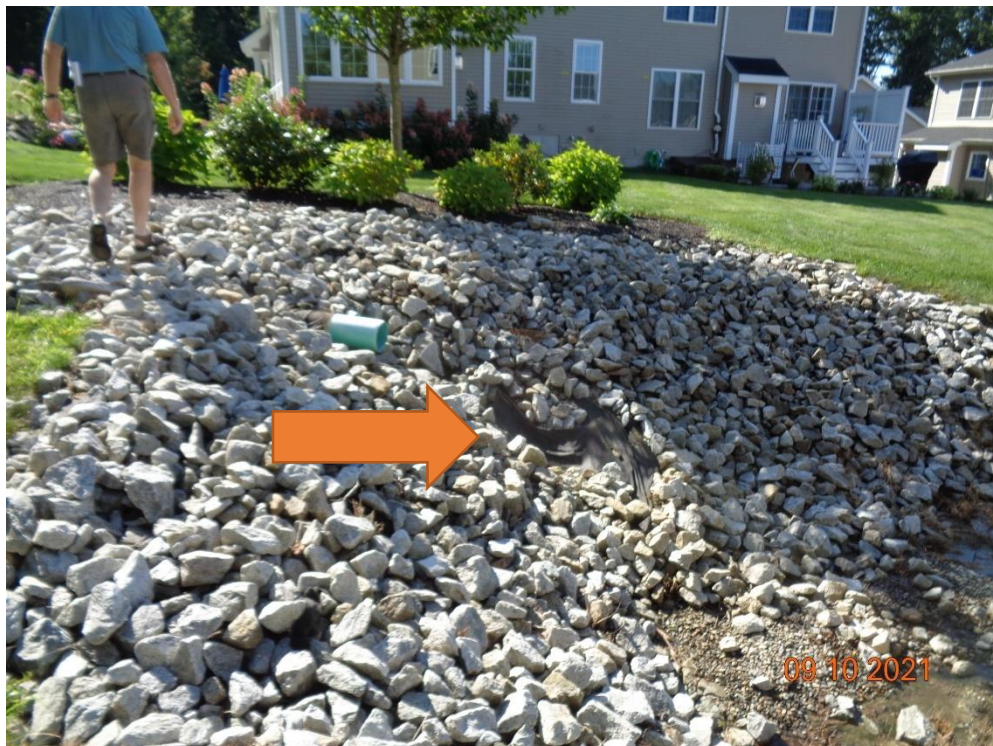
4. Riprap needs to be replaced or reset where it was displaced in the drainage plunge pool next to #29 Luka Drive. The replaced or reset riprap will have to be installed thick enough and of a large enough stone size to avoid being displaced by water discharged from the drainage pipe. Please see Photo 4.

Photo 4: Location where riprap needs to be reset next to #29 Luka Drive.
